STUCCO AND CLAY IN THE DECORATION OF THE MONUMENTAL BUILDINGS OF OLD NISA

Abstract – Unlike the terracotta decoration and the clay sculpture, the stucco production in Old Nisa has been only marginally studied. This is mainly due to the scarcity of figured materials available. Anyhow, recent excavations¹ have unearthed some fragments of sculptures in stucco and clay, along with double-moulds in gypsum mortar that shed new light on techniques for the manufacturing of sculptures. The manufacturing process of a sculpture is similar for both materials, since the modelling of the figure occurs through the gradual application of layers of clay or stucco (or both) more and more fine and purified. Moreover, for the two materials, is attested both the simple hand modelling and the use of moulds.

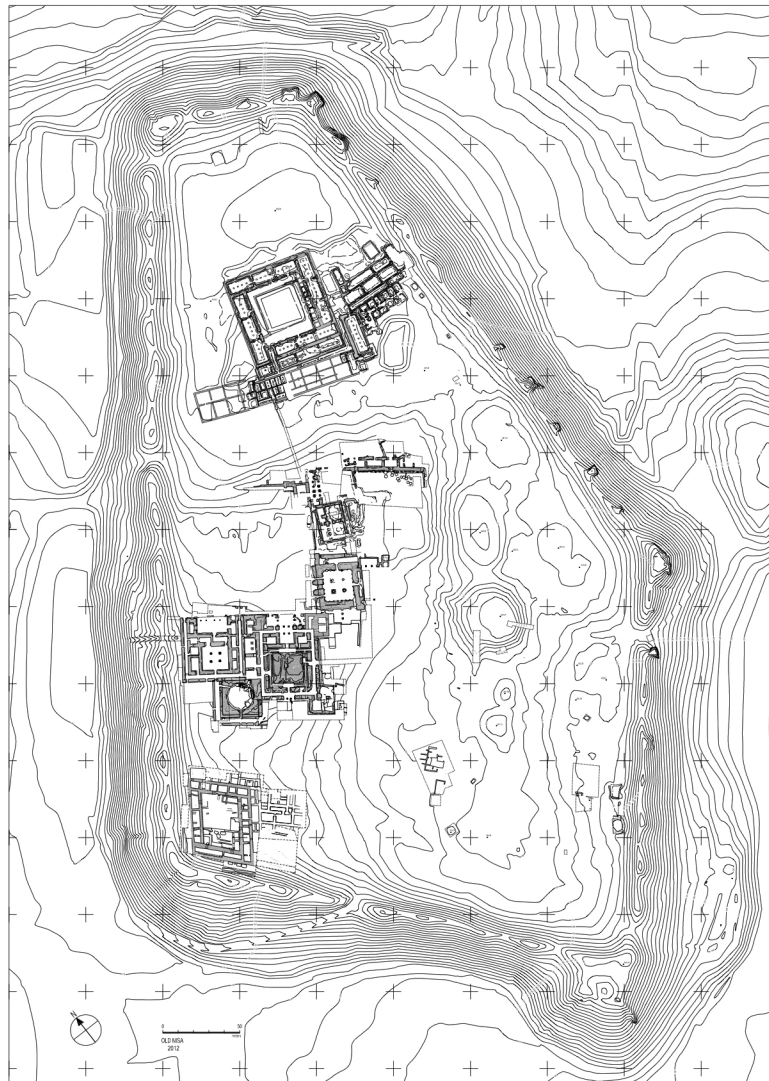
Figure 1. Old Nisa, plan © Archive Centro Ricerche Archeologiche e scavi di Torino

Today, Old Nisa (**fig. 1**) is generally interpreted as a great ceremonial centre dedicated to the glorification and celebration of the first Arsacids, the Parthian rulers, and its main buildings are dated between the 2nd cent. BC and the 1st-2nd cent. AD; it was then abandoned.²

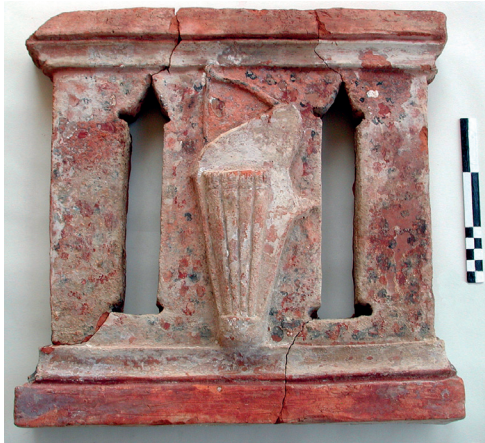
Figure 2. Old Nisa, metope in terracotta from the Red Building © Archive Centro Ricerche Archeologiche e scavi di Torino

The building material employed at Nisa was mainly clay.³ In terracotta were made, for instance, the so-called metopes (not metopes in a Greek-sense but slabs with a central symbolic motif flanked by arrow/column-like slots: the quiver, the Heracles' club, the lion's head, the Seleucid anchor, the crescent, the circle/sun), decorative slabs with a central rosette or palmette, indented bricks, stepped merlons with an arrow slot, acanthus leaves or plaques with volutes for Corinthian and Ionic assembled capitals (fig. 2-3).

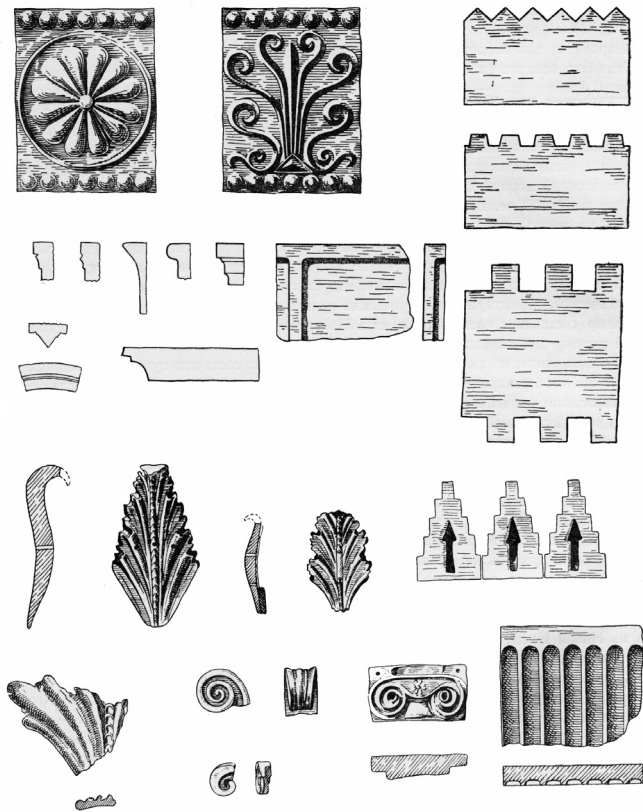
Figure 3. Architectural decorative elements in terracotta from Old Nisa (after PUGAČENKOVA 1949, p. 222-223)

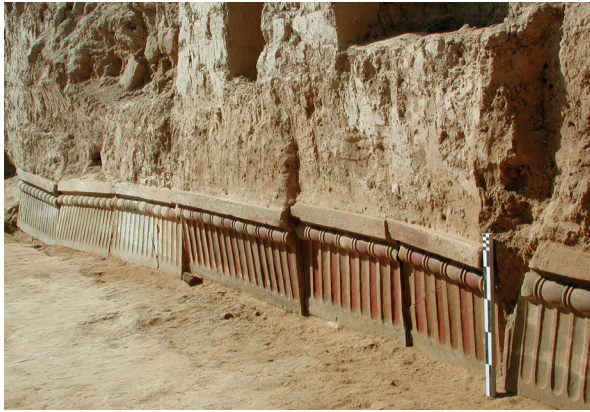
Figure 6. Red Building: stone dado-frieze
© Archive Centro Ricerche Archeologiche e scavi di Torino

The use of stone is rare in the architectural decoration of Nisa. Indeed, the material is not readily available in the area. From the oldest Parthian levels and especially from the façade of the Red Building comes a stone frieze: the bead-and-reel (astragalos) motif is western in its origin (though not unknown to the Achaemenid tradition)⁶ but here it is re-interpreted and displayed not on the top of the wall but in its lower portion, like a *dado*, with obvious functional purposes of protection (fig. 6).

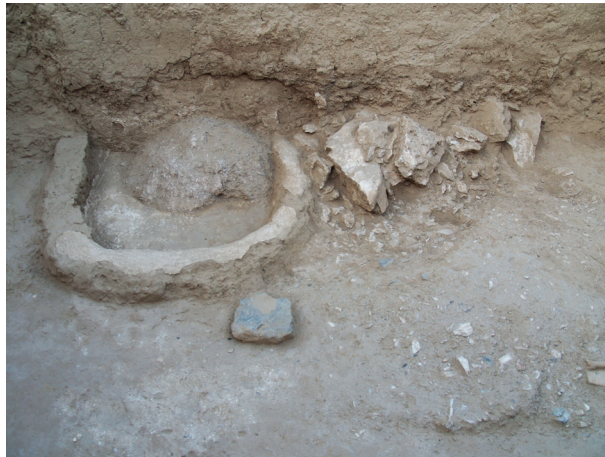
Figure 10. Old Nisa, South-Western Building: basin in room 44 © Archive Centro Ricerche Archeologiche e scavi di Torino

The production process of gypsum-based material may be recognized in some rooms of the recently excavated area (South-Western Area) at Old Nisa. Inside the so-called South-Western Building plastered basins were laying directly on the floor of room 44 (fig. 10). In the corner of two of these basins, two heaps of powdered “anhydrite” agglomerate were found. Immediately beside the basin, some raw blocks and crushed stones of this same mineral were lying on the floor of the room, clearly part of the two previous (i.e. intermediate) processing stages. It seems that here we have installations meant for the processing and production of mortar, plaster or stucco. Moreover, substantial traces of ashes and fire activities, clearly related to the same production process, were lying on the floors of rooms 45a and 45b, adjacent to room 44 where the agglomerates of anhydrite were found.¹⁵

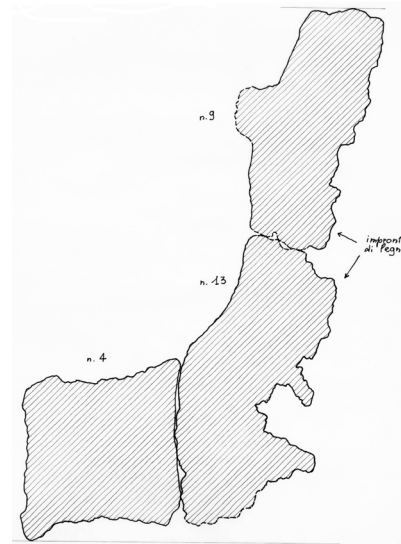
Figure 11. Gypsum fragments from the Round Hall © Archive Centro Ricerche Archeologiche e scavi di Torino

As already mentioned, finds of stucco cornices are rather limited in Nisa. In the Round Hall, after the collapse of the upper part of the walls, several fragments of stucco decoration were probably piled at the edges of the circular room. In general, these fragments are in such deplorable conditions that it is difficult even to guess at their original shape (fig. 11). In any case, we can reasonably imagine that very simple moulded cornices decorated the walls of the buildings of Nisa, mainly, if not exclusively, with linear motives.

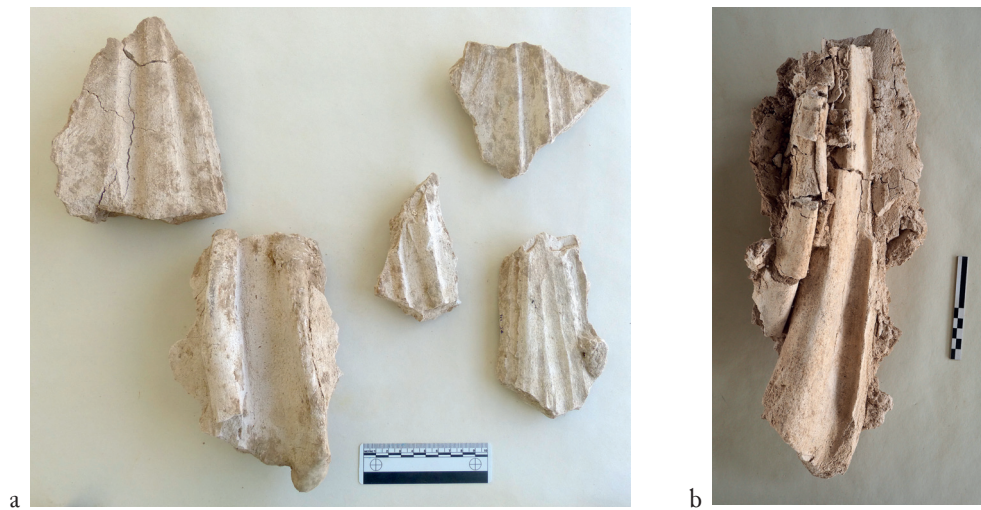
Figure 12. South-Western Building: gypsum-stucco fragments of statues from the pit
© Archive Centro Ricerche Archeologiche e scavi di Torino

This finest “plaster” coating is also visible on some fragments of stucco found in a large pit inside the South-Western Building, filled in a late stage with earth, pottery and architectural elements no longer in use (fig. 12). All the stucco fragments depict drapery of garments, and closely resemble similar fragments of clay statues discovered in the Round Hall.¹⁷

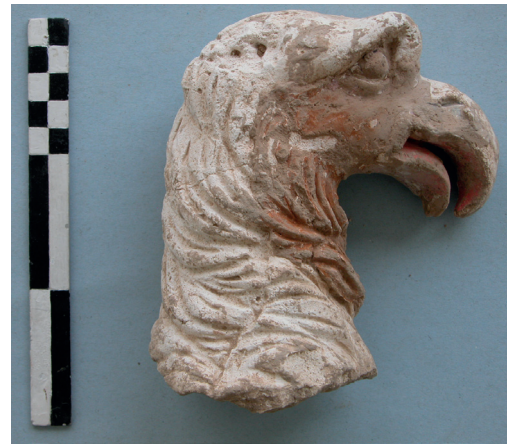
Figure 14. Red Building, southern façade: stucco eagle's head © Archive Centro Ricerche Archeologiche e scavi di Torino

That these two techniques, in clay and in stucco, were closely related is also evident in one final example. From the Red Building's southern façade come a few fragments of a stucco sculpture depicting an eagle (fig. 14). It seems likely that this sculpture, which was life size, belonged to a frieze originally displayed on the walls of the main tetrastyle hall of the building. This is not the place to discuss the symbolism of the eagle among the Parthians, but it is clear that the presence of this iconography on the walls of one of the main buildings of Nisa's ceremonial complex is closely linked to the idea and propaganda of the Arsacid kings. The figure, especially its head and neck, shows a rich and plastic treatment—we can say almost

In the Nisean eagle the colour was not directly applied on the stucco surface, but on a very thin (ca. 2 mm) layer of clay covering it. The application of a thin layer of purified clay on the stucco surface is a further confirmation of how the two production techniques, for stucco and clay sculptures, were similar, the final colouring providing uniformity to the whole and making imperceptible the difference between the two materials.

The stucco eagle(s) of Nisa were not sculptured in the round and were cast by single moulds. The back of the head is hollow and traces of housings for the metal clamps that originally fixed this sculpture to the wall are still clearly recognizable.
